CRM BULLETIN

Cultural Resources Management

A National Park Service
Technical Bulletin

Twenty-Eight Coats of White House History

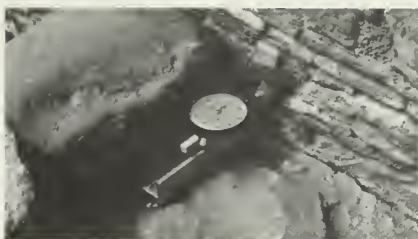
This dial gauge installation produced the data in the line chart. The gauge is mounted on top of a wall on one side of the crack. A metal plate is attached to the taller back wall. The spring-loaded spindle of the gauge rests on the metal plate, but is not attached to it. As crack width changes, the spindle moves and changes the position of the gauge hands.

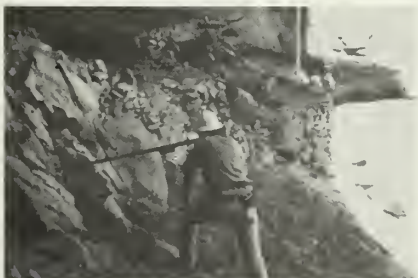
Precise leveling equipment being used to measure settlement of ruins. While similar to conventional surveying in technique, specialized equipment allows direct readings of 1/10 mm with estimates to 1/100 mm.
